**THÈSE**

**Influence of casting defects on the  
fatigue behaviour of an A357-T6  
aerospace alloy**

**l'Institut National des Sciences Appliquées de Lyon**

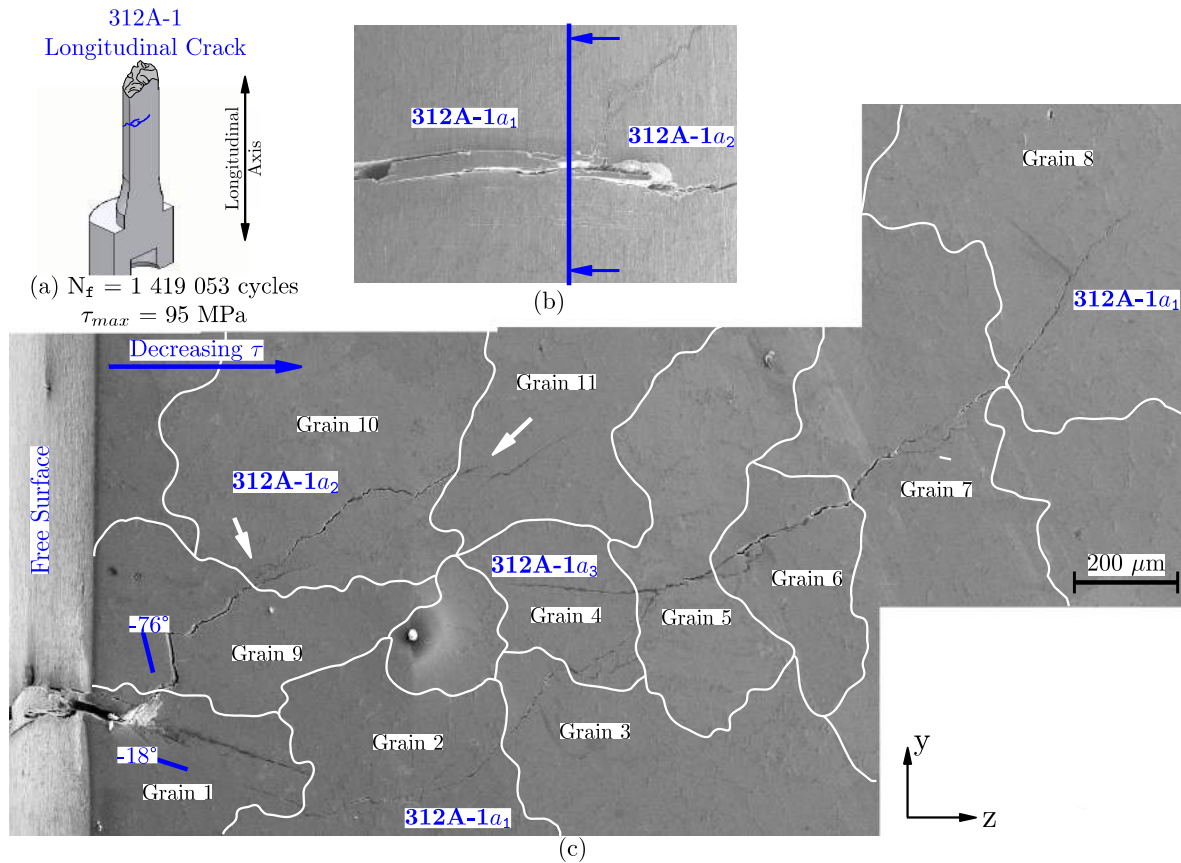
**Fig. 2.51:** (a) Schematic illustration of the longitudinal cut performed on 312A-1 secondary crack. (b) SEM image showing the approximate location of the cut on the free surface. (c) SEM image on the cut showing the crack path formed towards the interior of the specimen. 312A-1a<sub>1</sub> crack reached a 2 mm length. White lines indicate the approximate location of the grain boundaries obtained by EBSD. The two white arrows indicated the crack discontinuities observed when 312A-1a<sub>2</sub> crack crosses the grain boundaries of Grain 10 and Grain 11.

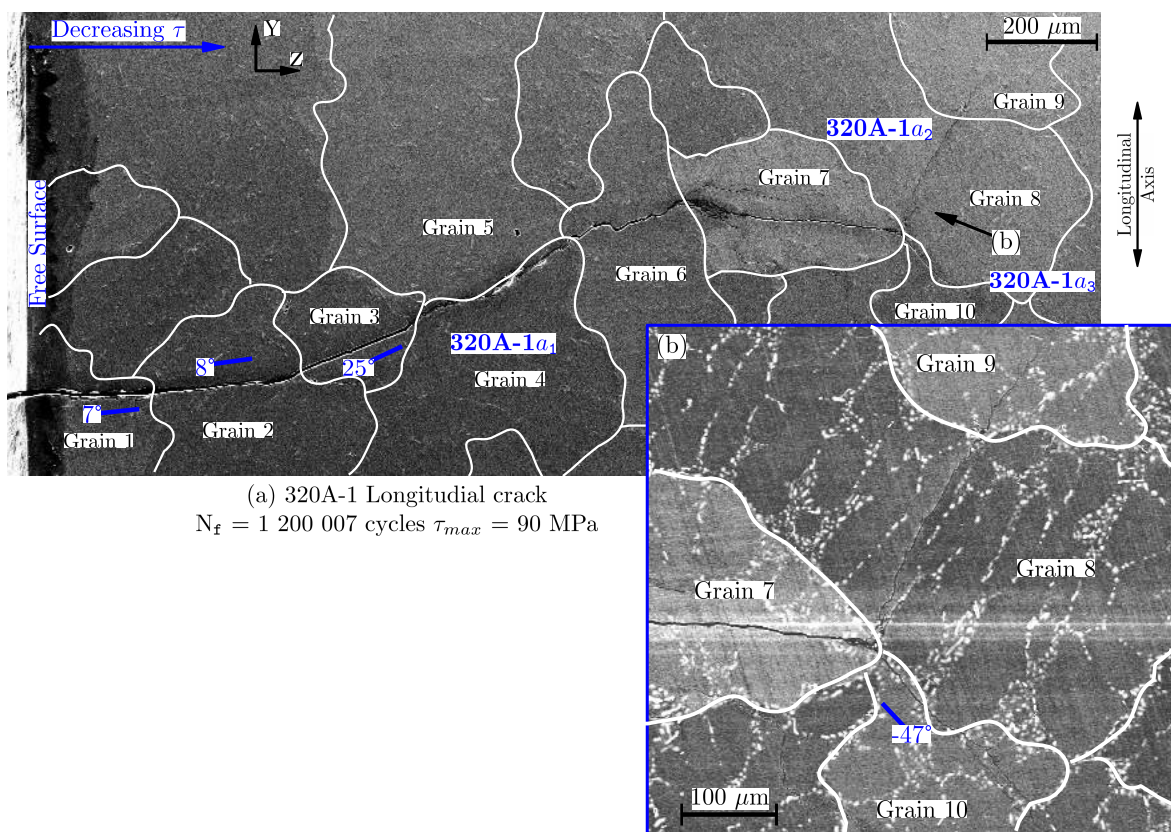
**Fig. 2.54:** (a) SEM image on the cut of 320A-1 specimen presenting the crack path formed towards the interior of the specimen. The white lines indicate the approximate location of the grain boundaries obtained by EBSD. (b) Higher magnification (BSE image) at the end of the crack where a very pronounced bifurcation occurred at a triple point. The total length of this crack from the free surface is 1740  $\mu\text{m}$ .

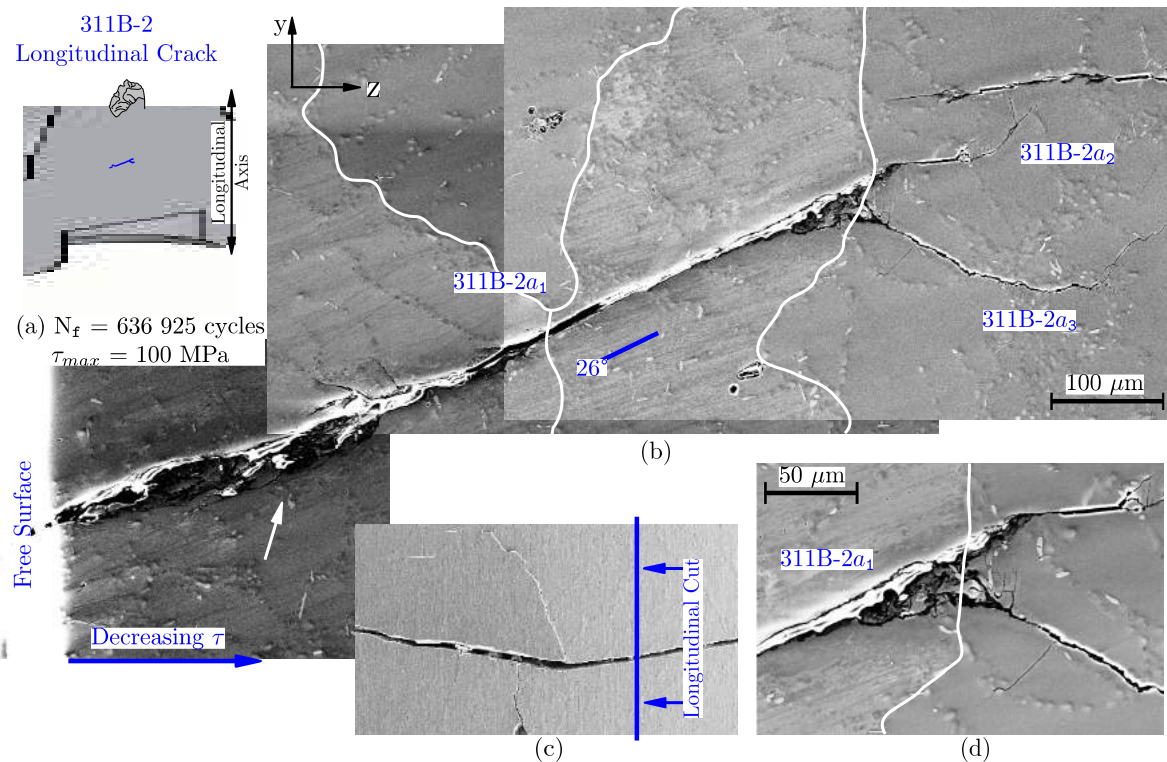
**Fig. 2.55:** (a) Schematic illustration of the longitudinal cut performed on 311B-2 secondary crack. (b) SEM image on the cut showing the crack path formed towards the interior of the specimen. The white lines indicate the presumed location of some grain boundaries (no EBSD analysis was performed on this sample). (c) SEM image showing the approximate location of the cut on the free surface. (d) Higher magnification of the branch. The white arrow indicates the extensive abrasion debris formed under the free surface.

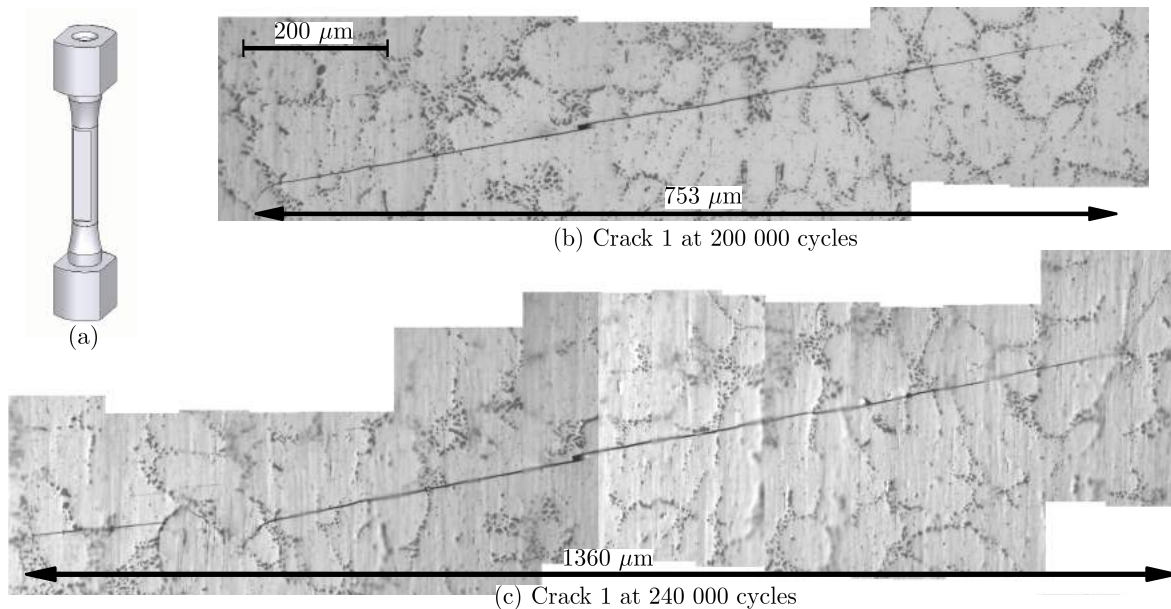
**Fig. 2.56:** (a) 3D rendering of a torsion specimen showing a flat along the gage length. (b) MO image of 329B-Crack 1 progression after 200 000 cycles. (c) The same as before but for 240 000 cycles.

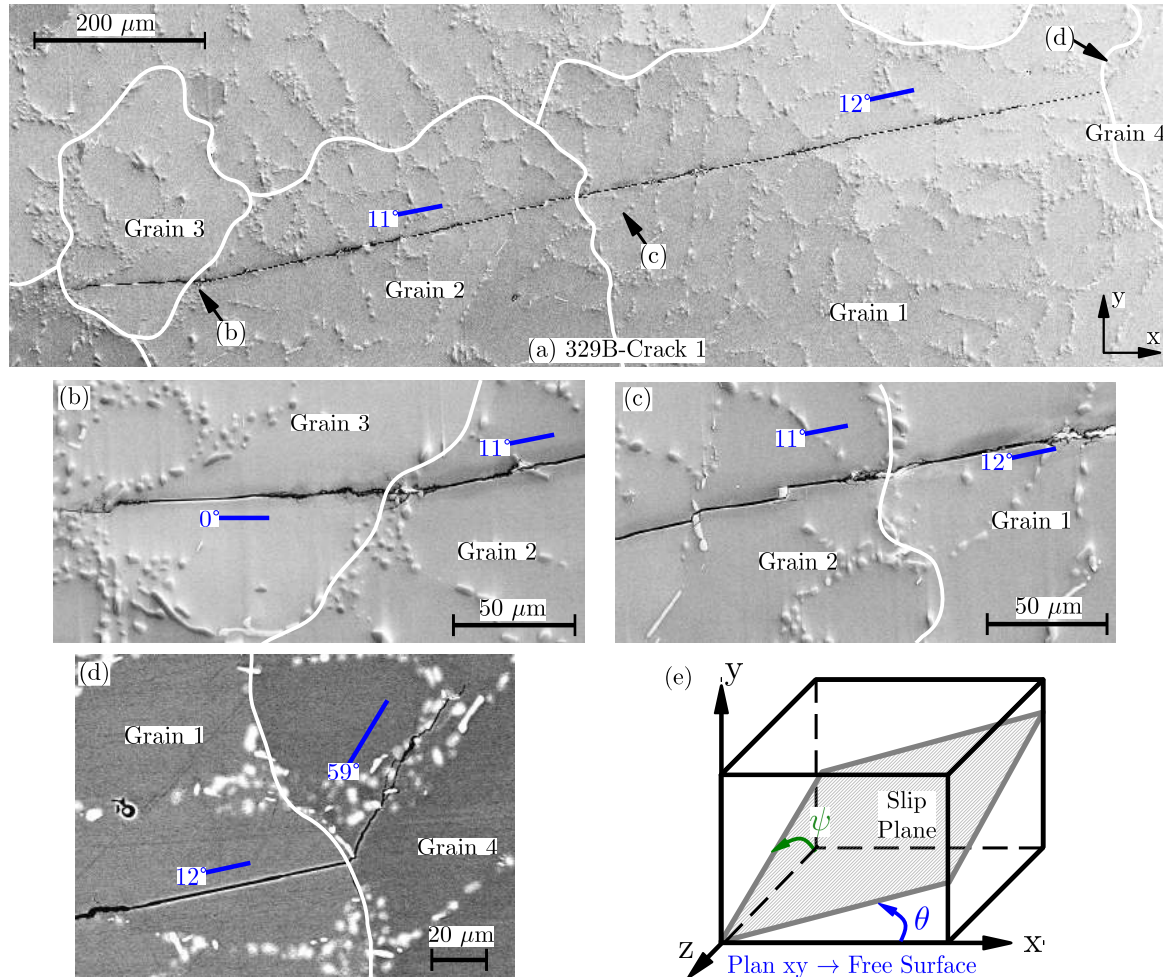
**Fig. 2.57:** (a) SEM observation showing propagation of 329B-Crack 1 through four different grains. The white lines indicate the approximate location of the grain boundaries. (b) Higher magnification of the crack crossing between Grain 2 and Grain 3. (c) The same as before but for Grain 1 and Grain 2. (d) BSE image of the crossing between Grain 1 and Grain 4. (e) Schematic illustration of the  $\theta$  and  $\psi$  angle.

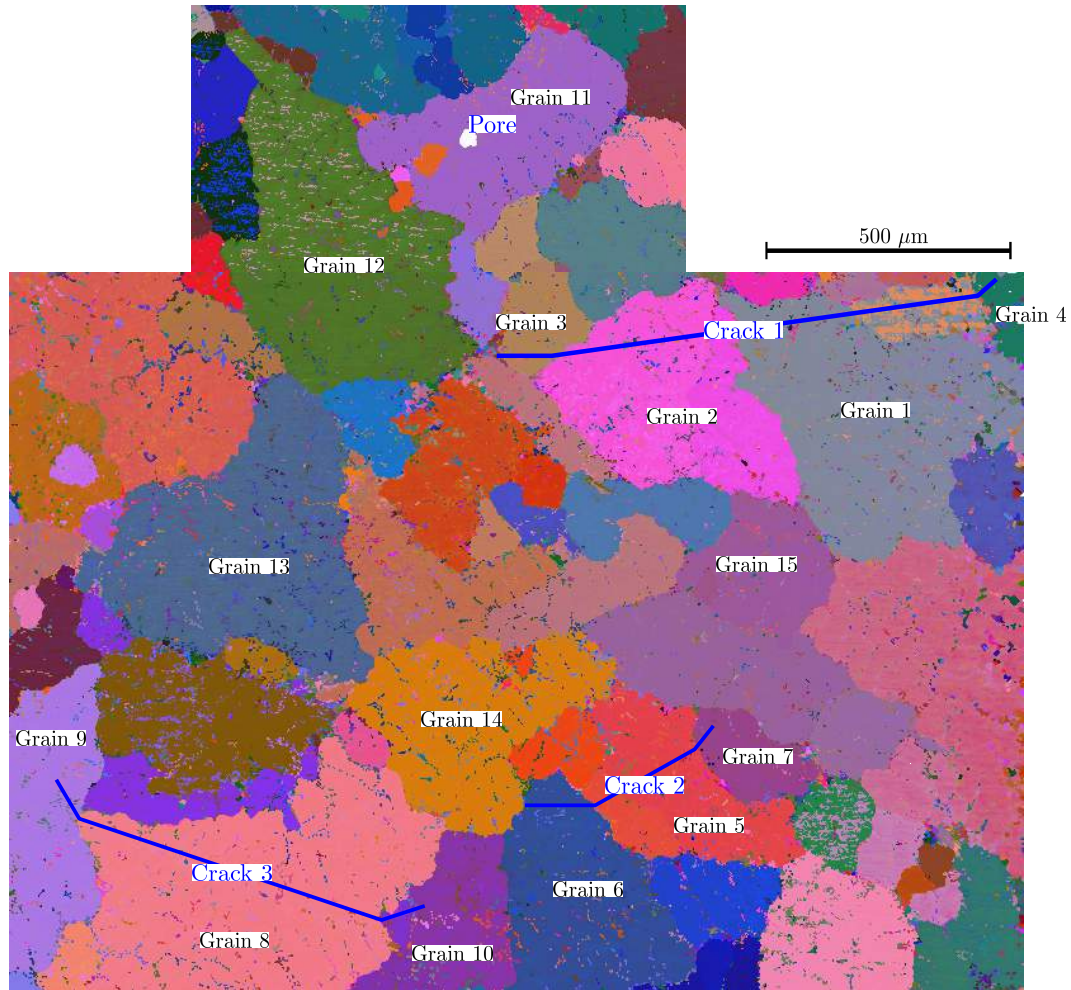
**Fig. 2.60:** EBSD Euler map showing the grain population of the 329B filleted surface with a schematic representation of the cracks. The labelled grains were used as input for a Taylor analysis.

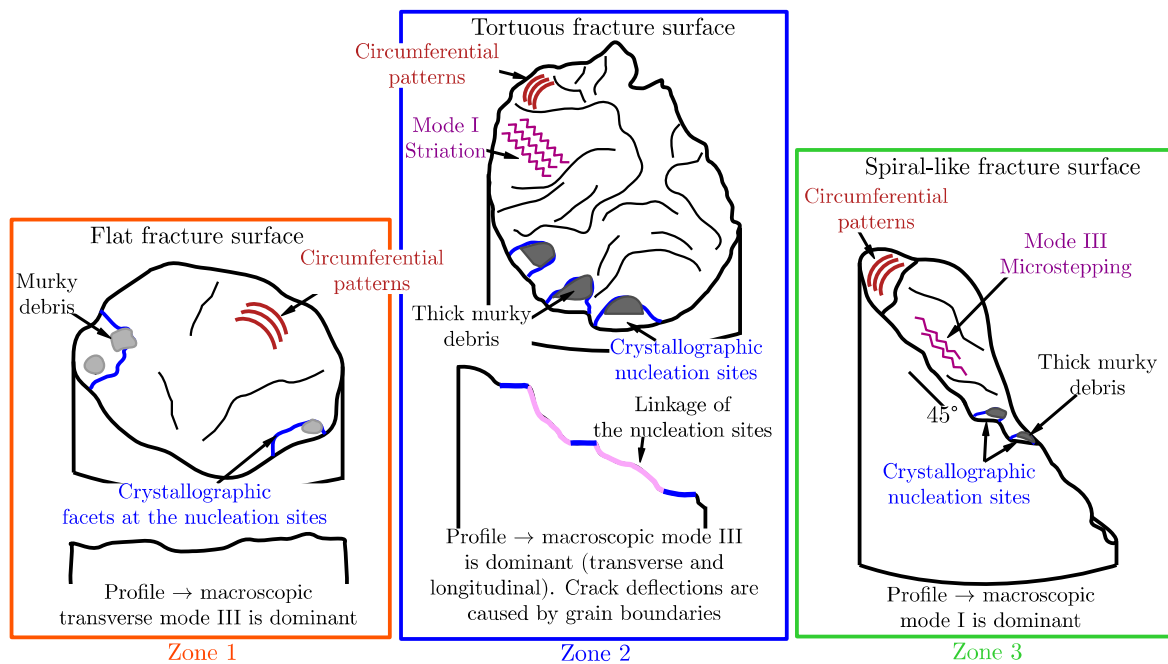
**Fig. 2.61:** Schematic illustration of the most remarkable features that have been observed in Zone 1, Zone 2 and Zone 3

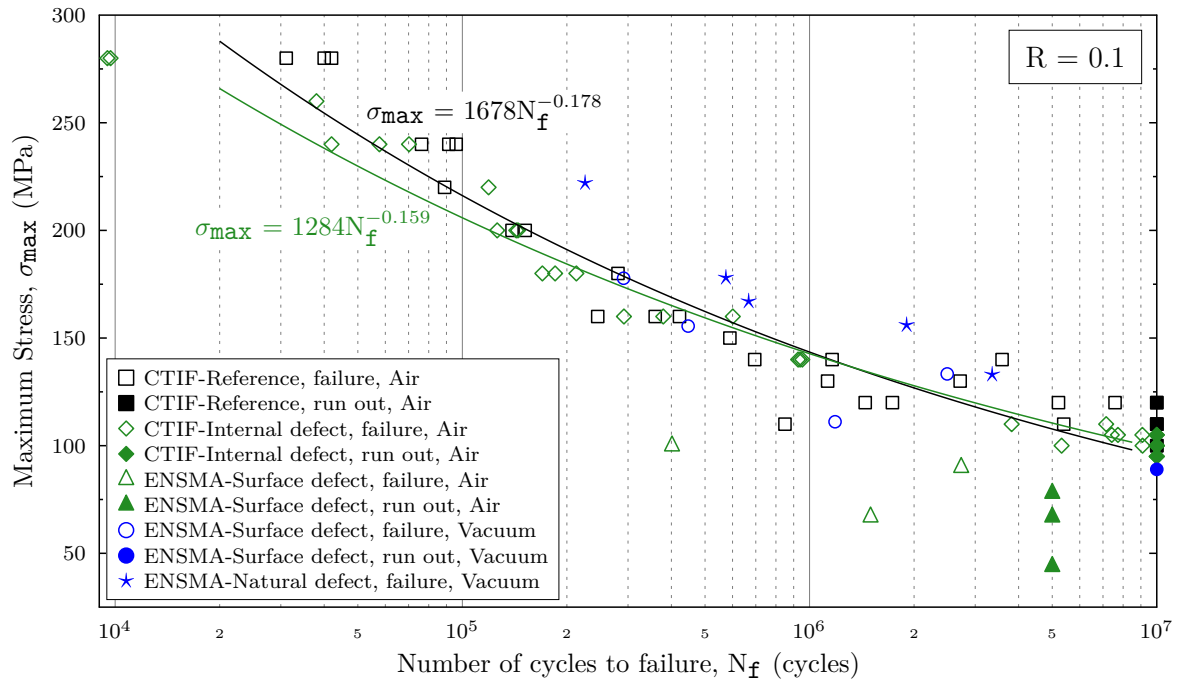
**Fig. 3.5:** S-N curves for both reference material and specimens containing internal artificial defects of  $\varnothing_{eq} \approx 2$  mm cycled in ambient air. The graph also shows results obtained with specimens where one half of the artificial defect intercepts the free surface (cycled in air or vacuum environment) and to the reference material cycled in vacuum.

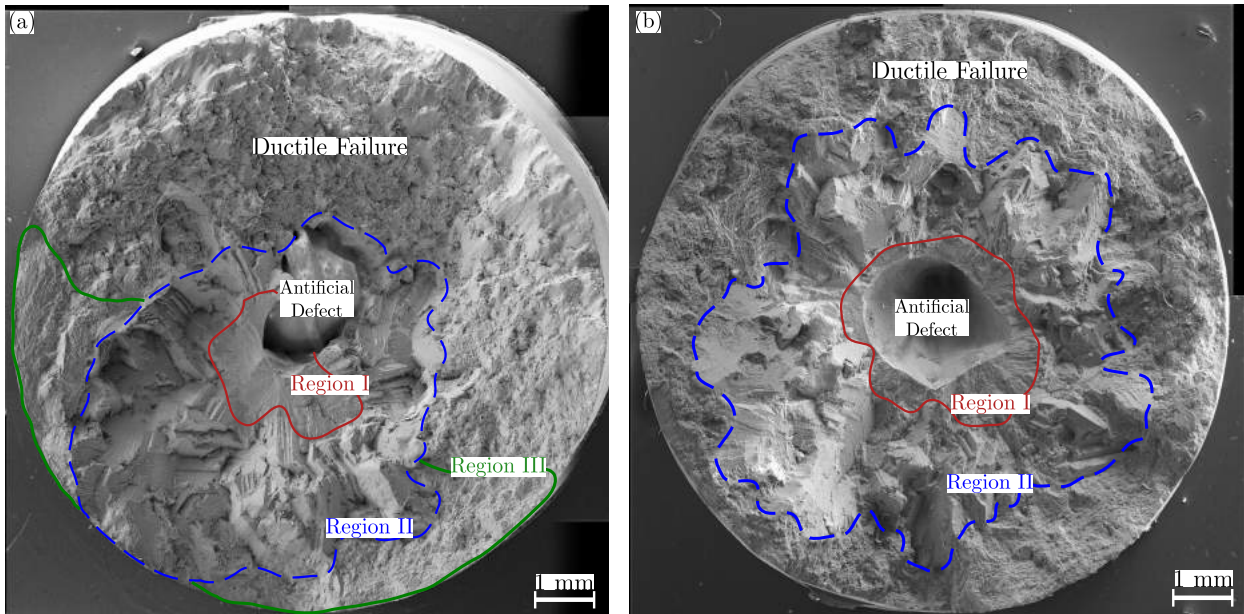
**Fig. 3.6:** (a) SEM observations at low magnification on the fracture surface of CTIF-131.104 specimen (ambient air) where three distinct regions of fracture topography are reported (see the main text for details). The rest of the surface corresponds to the final ductile failure. The fatigue testing parameters are:  $N_f = 9\,089\,100$  cycles,  $\sigma_{max} = 105$  MPa, Artificial Defect  $\sqrt{A} = 1872$   $\mu\text{m}$  and Region I surface and  $A = 2.9$   $\text{mm}^2$ . (b) SEM observations on the fracture surface of CTIF-131.114 specimen (ambient air) which only presents propagation in Region I and Region II before final failure. The testing parameters are:  $N_f = 600\,800$  cycles,  $\sigma_{max} = 160$  MPa, Artificial Defect  $\sqrt{A} = 2116$   $\mu\text{m}$  and Region I surface and  $A = 3.4$   $\text{mm}^2$ .

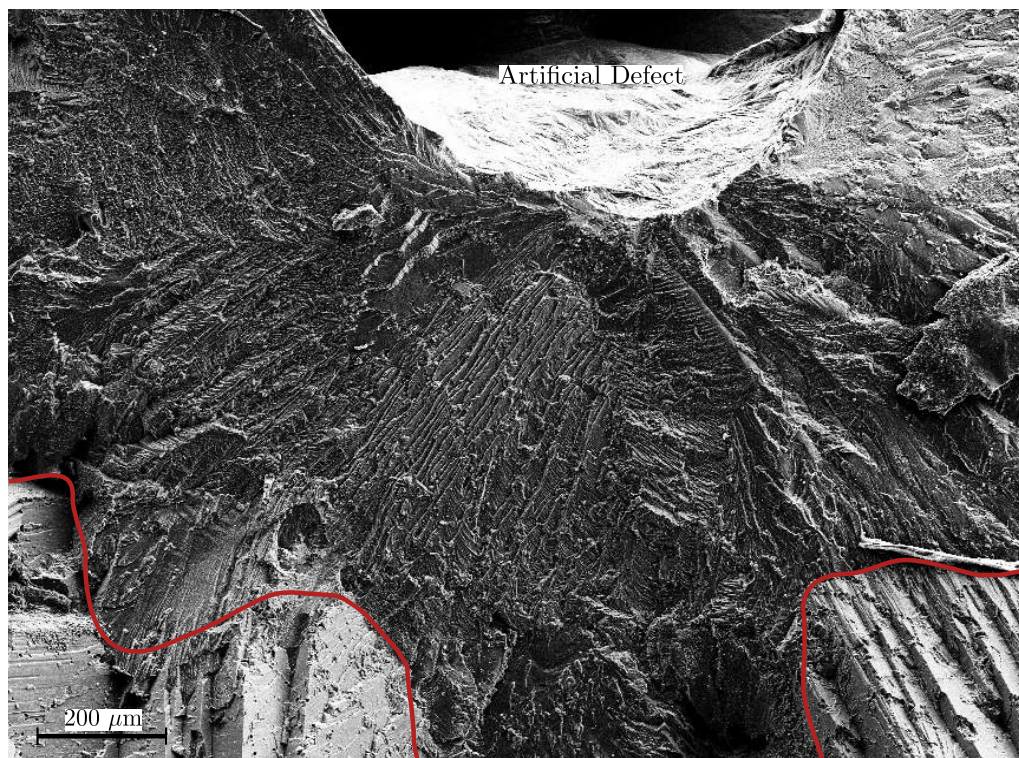
**Fig. 3.7:** Higher magnification on the Region I of CTIF-131.104 fracture surface. This surface is predominantly flat and shows a series of radial ridges.

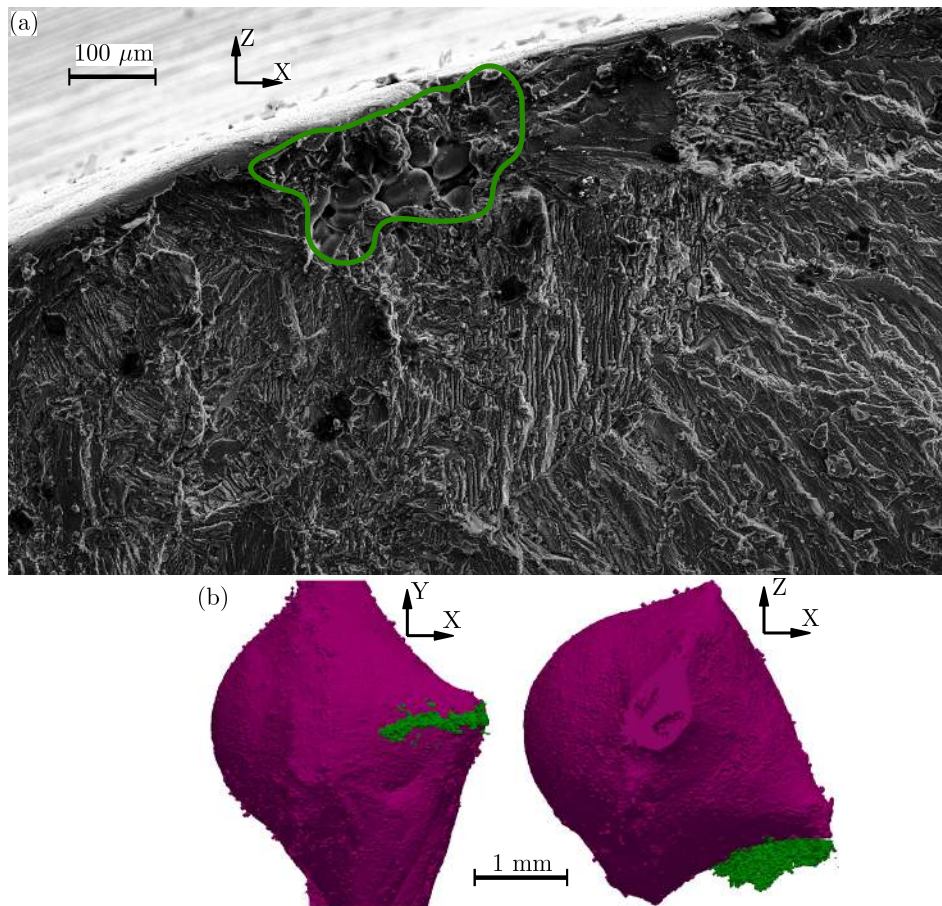
**Fig. 3.8:** (a) SEM observation at high magnification on the fracture surface of CTIF-101.57 specimen (ambient air,  $N_f = 938\,500$  cycles,  $\sigma_{\max} = 140$  MPa) where a surface natural defect of  $\sqrt{A} = 195\,\mu\text{m}$  was the cause of the fatal failure. (b) 3D renderings obtained by synchrotron tomography of the internal artificial defect ( $\sqrt{A} = 2064\,\mu\text{m}$ ) present in the specimen gage. The crack (which did not lead to failure) is shown in green while the artificial defect appears in magenta.

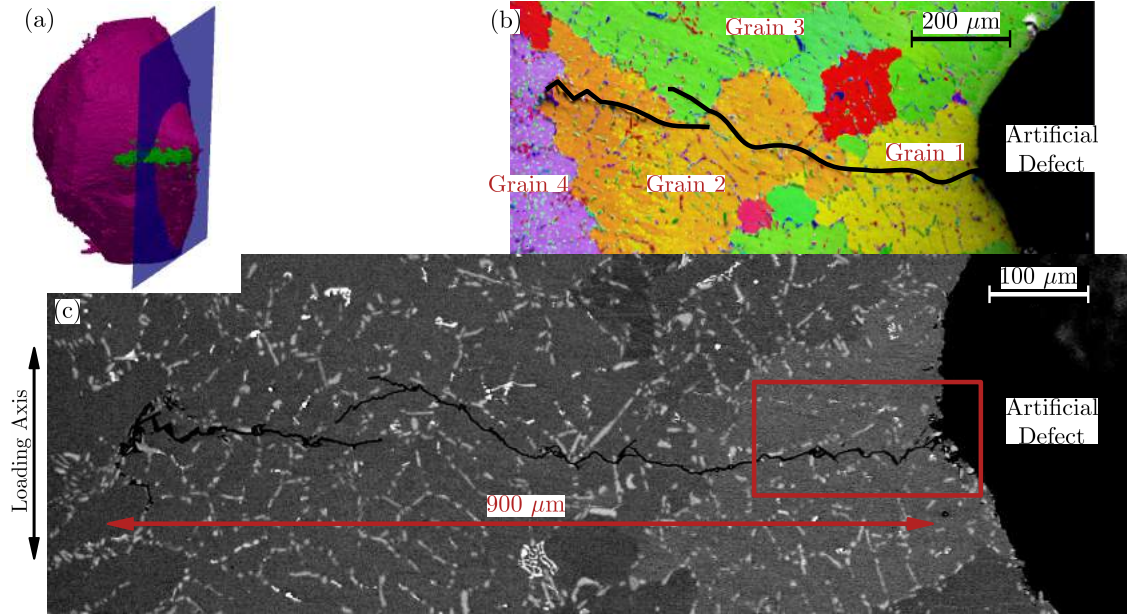
**Fig. 3.9:** (a) 3D rendering showing the approximate location of the longitudinal cut on CTIF-101.57 specimen (ambient air). (b) EBSD Euler map showing grain distribution around the artificial defect. (c) Backscattered electron image on the non-crystallographic crack. The red rectangle indicates a zone of clear stage II propagation.

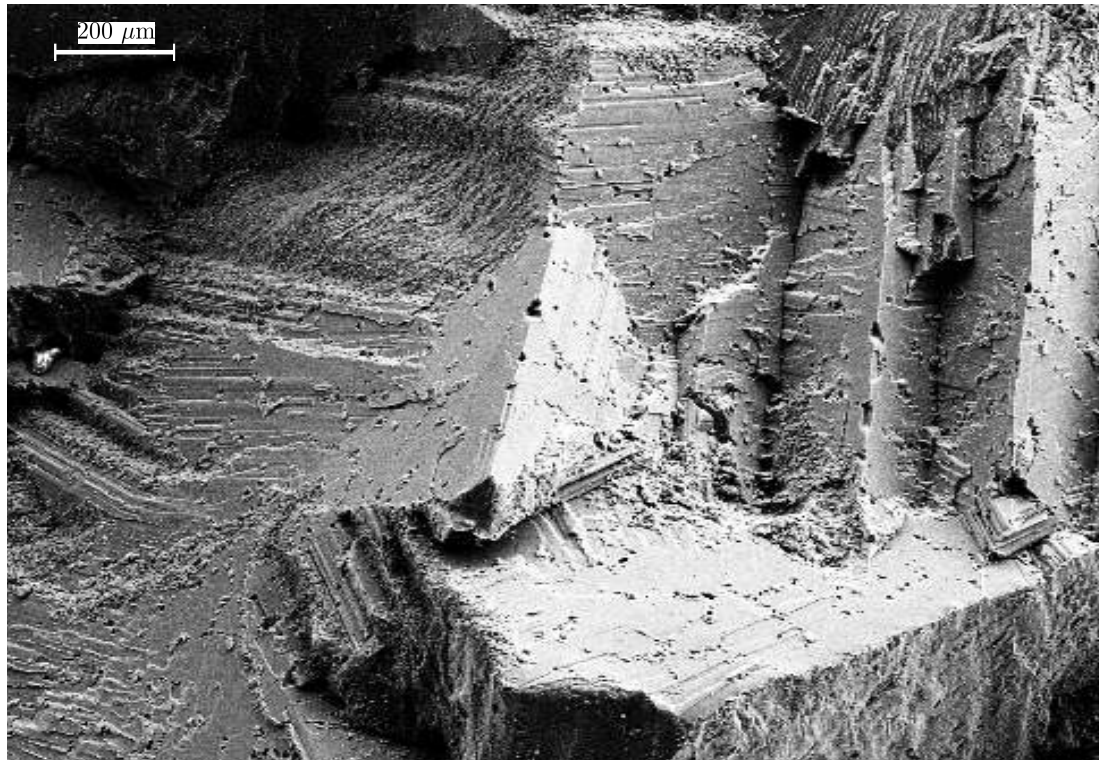
**Fig. 3.10:** Higher magnification on the Region II of CTIF-131.104 fracture surface where a zigzag topography can be observed due to large crystallographic facets.

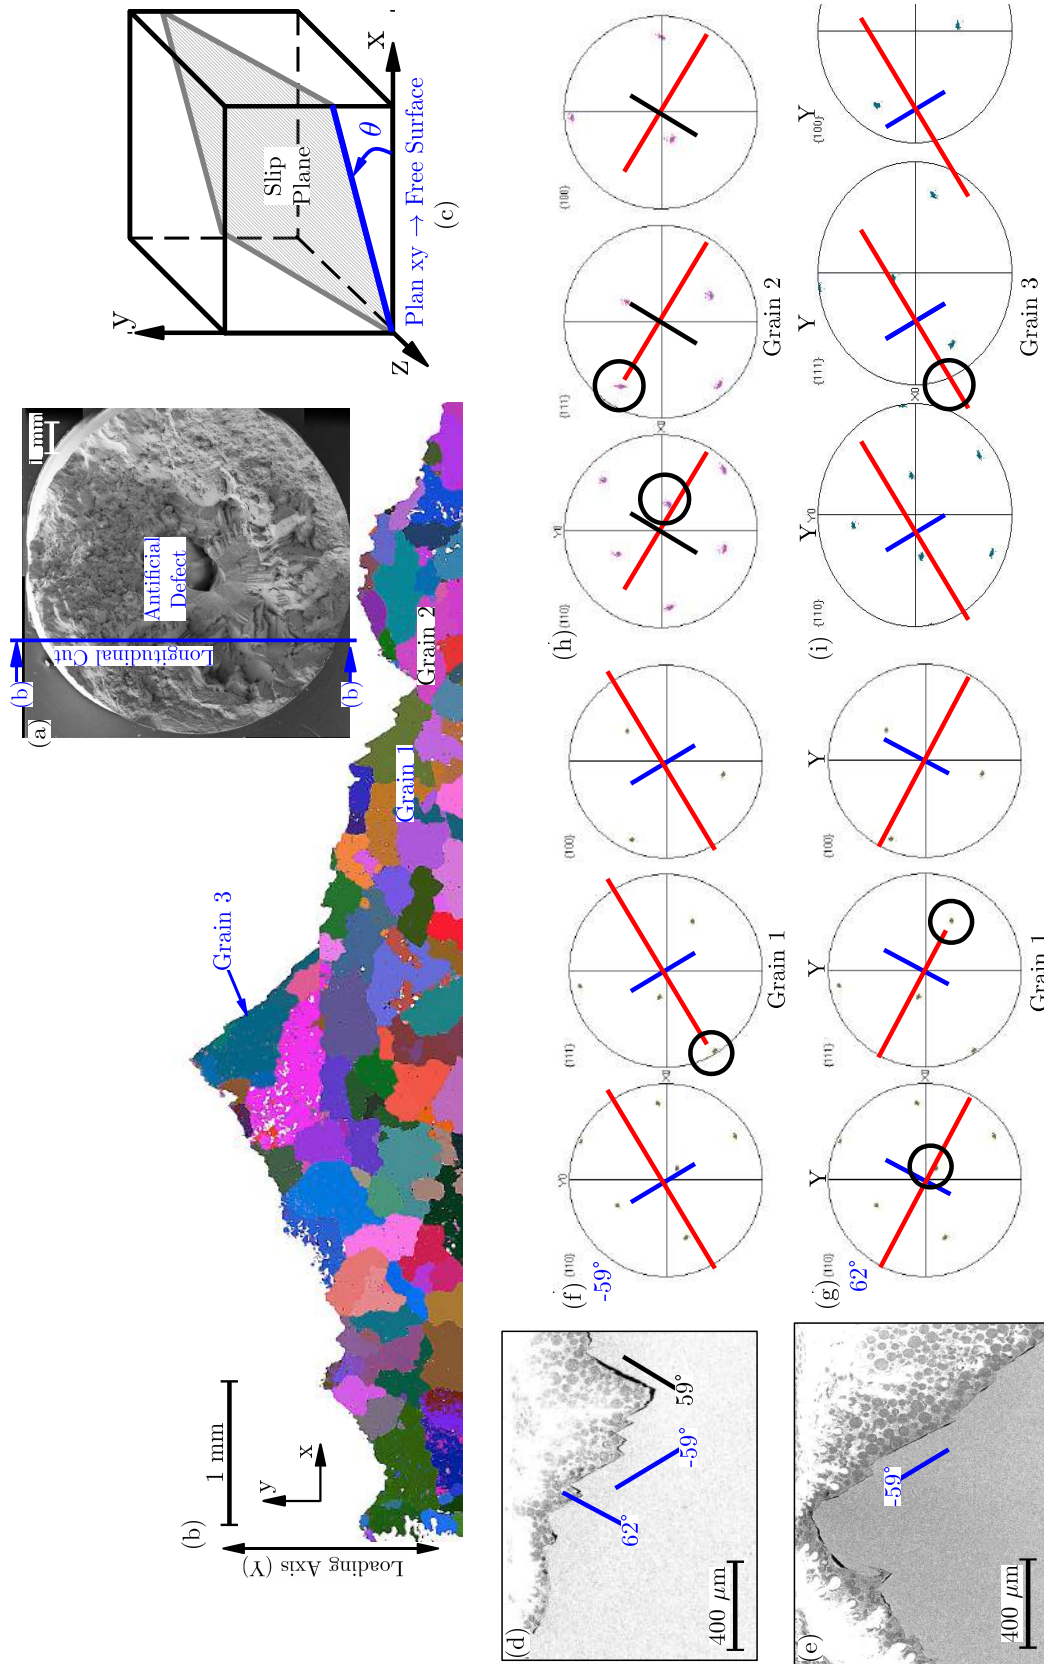
**Fig. 3.11:** (a) Fracture surface of the upper half of CTIF-131.104 specimen (cycled in ambient air) indicating the approximate location of the longitudinal cut. (b) EBSD Euler map of the longitudinal cut performed on the lower half which shows grain distribution along the internal crack. Only the grains exhibiting crystallographic propagation are labelled. (c) Schematic illustration of the  $\theta$  angle which indicates the trace orientation. (d) SEM image showing the direction of crack propagation within Grain 1 and Grain 2. (e) Same as before but for the case of Grain 3. (f)-(i) Surface trace analysis on  $\{111\}$ ,  $\{110\}$ ,  $\{100\}$  stereographic projection pole-figures.  $\{111\}$  family is the only one that always shows interceptions with the normals.

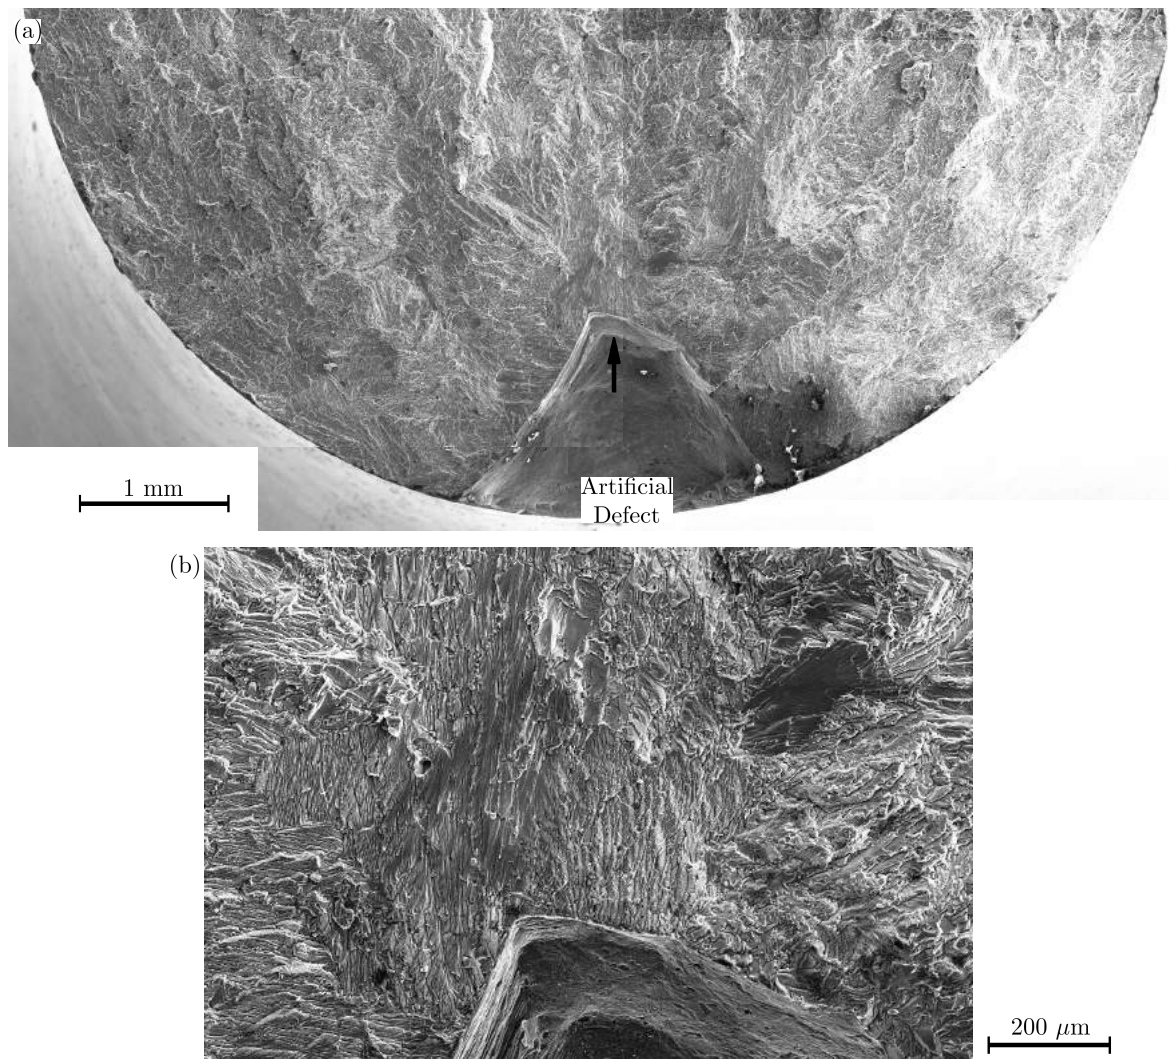
**Fig. 3.14:** (a) SEM observations on the fracture surface of ENSMA-SDA-03 specimen (ambient air,  $N_f = 1\,498\,500$  cycles,  $\sigma_{\max} = 67$  MPa, Artificial Defect  $\sqrt{A} = 1377$  μm). Only Region III propagation is observed. (b) Higher magnification on the first propagation stages from the surface defect, close to the region indicated by the black arrow.

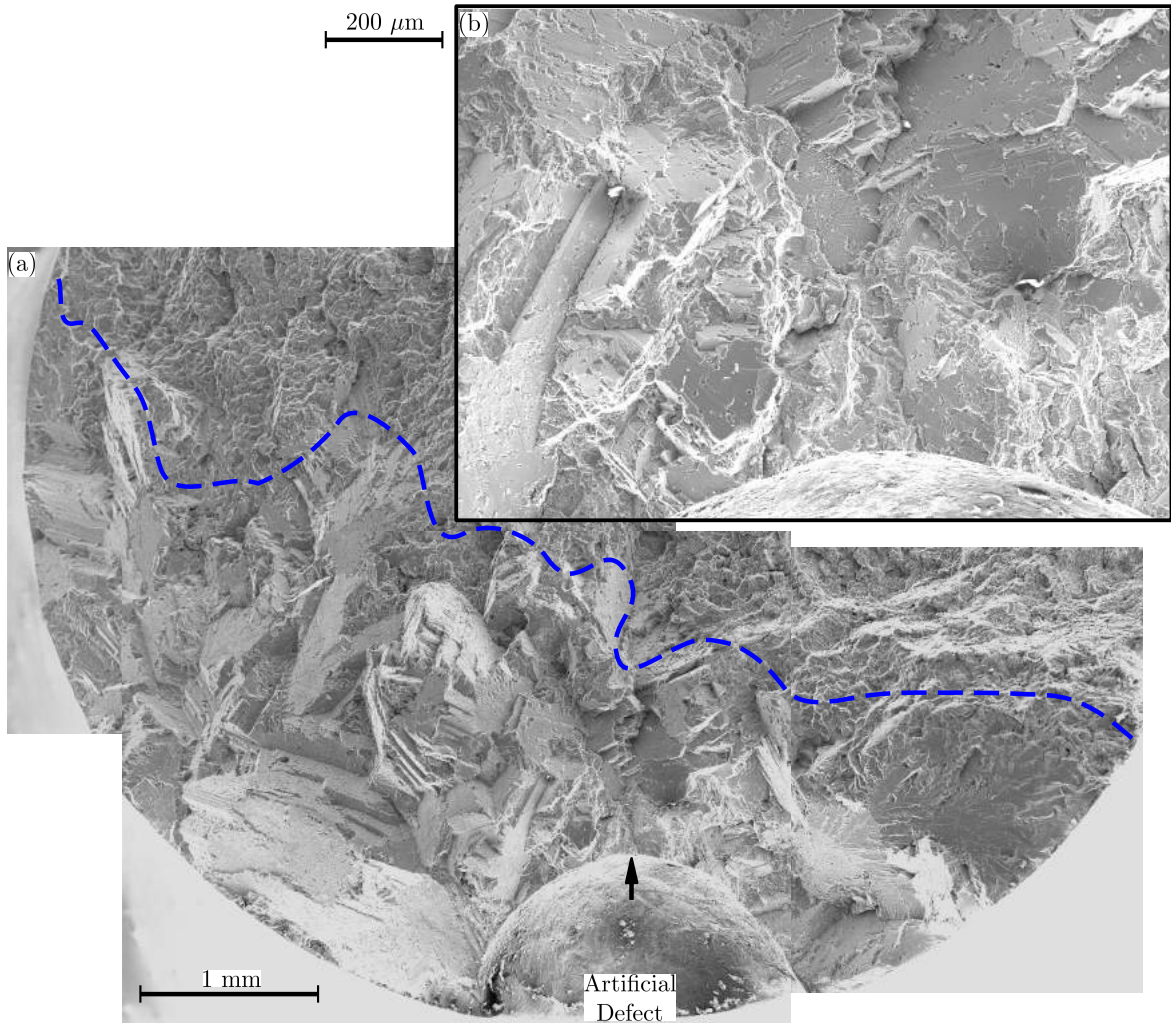
**Fig. 3.15:** (a) SEM observations on the fracture surface of ENSMA-SDV-01 specimen (vacuum,  $N_f = 2\,491\,343$  cycles,  $\sigma_{\max} = 133$  MPa, Artificial Defect  $\sqrt{A} = 1215\,\mu\text{m}$ ). Only Region II propagation is observed. (b) Higher magnification on the first propagation stages from the surface defect, close to the region indicated by the black arrow.

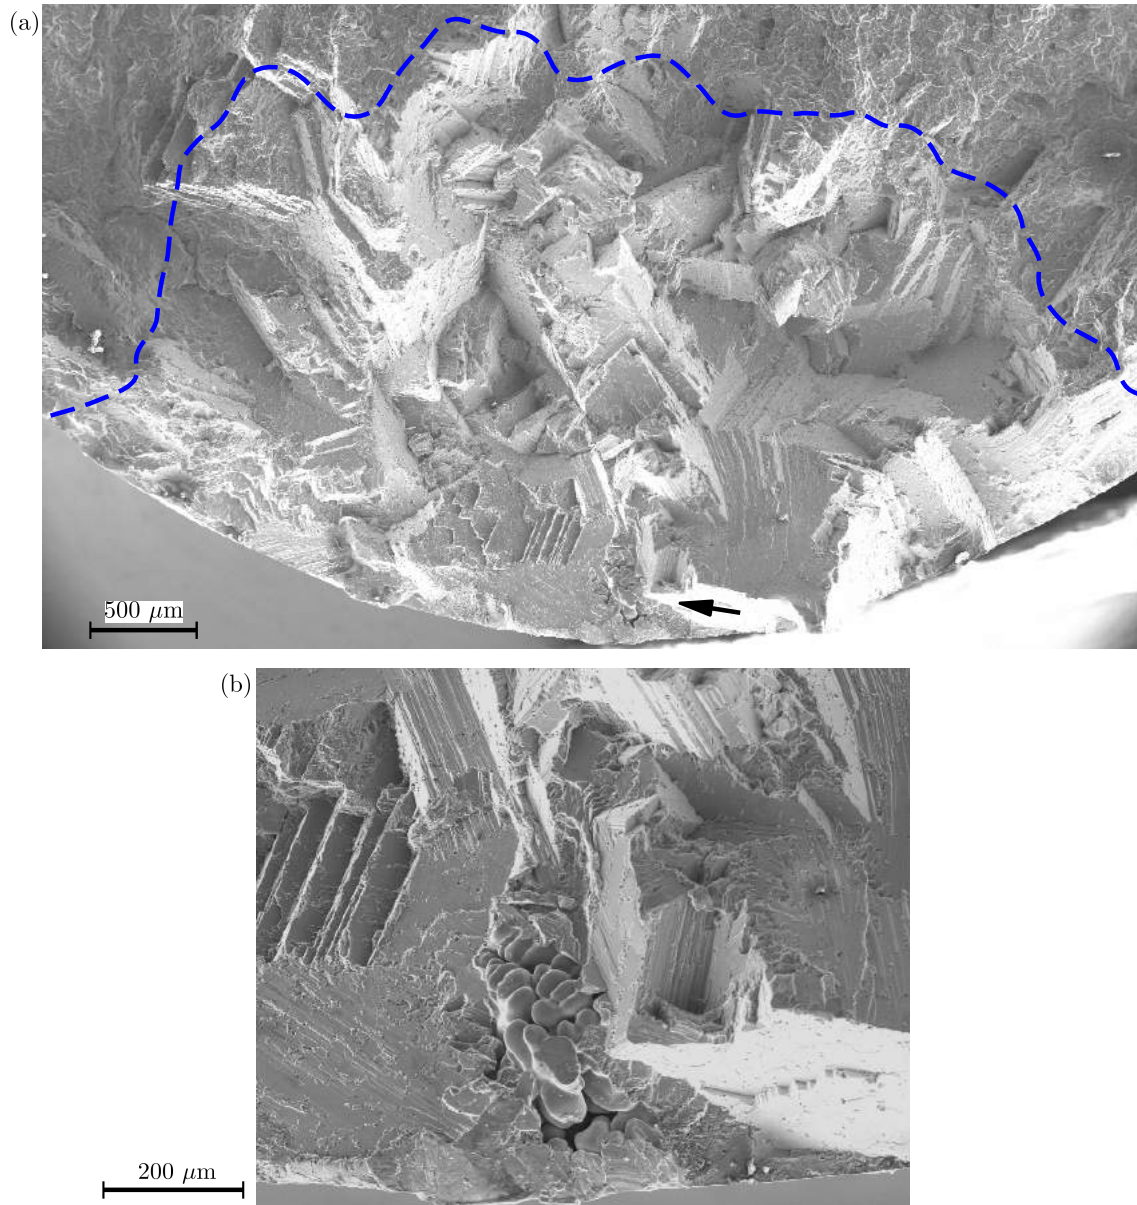
**Fig. 3.16:** (a) SEM observations on the fracture surface of ENSMA-SNV-03 specimen (vacuum,  $N_f = 3\,356\,341$  cycles,  $\sigma_{\max} = 133$  MPa, Artificial Defect  $\sqrt{A} = 278$  μm). Only Region II propagation is observed. (b) Higher magnification on the first propagation stages from a surface microshrinkage, close to the region indicated by the black arrow.

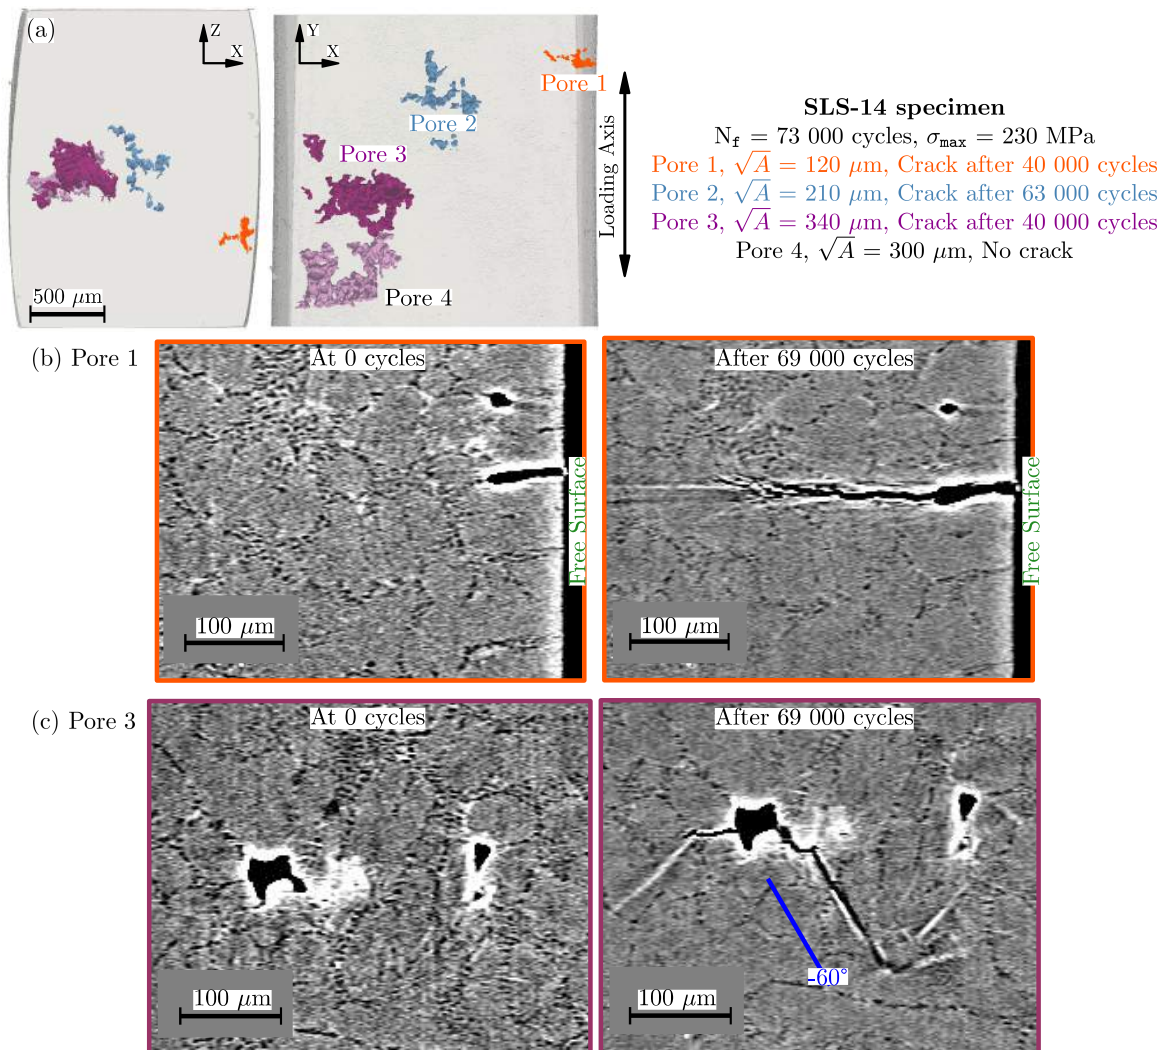
**Fig. 3.18:** (a) Pore distribution within the gage of SLS-14 specimen. (b) Synchrotron tomographic images showing surface Pore 1 fatigue progression at 0 and 69 000 cycles. (c) The same as before but for the case of internal Pore 3.

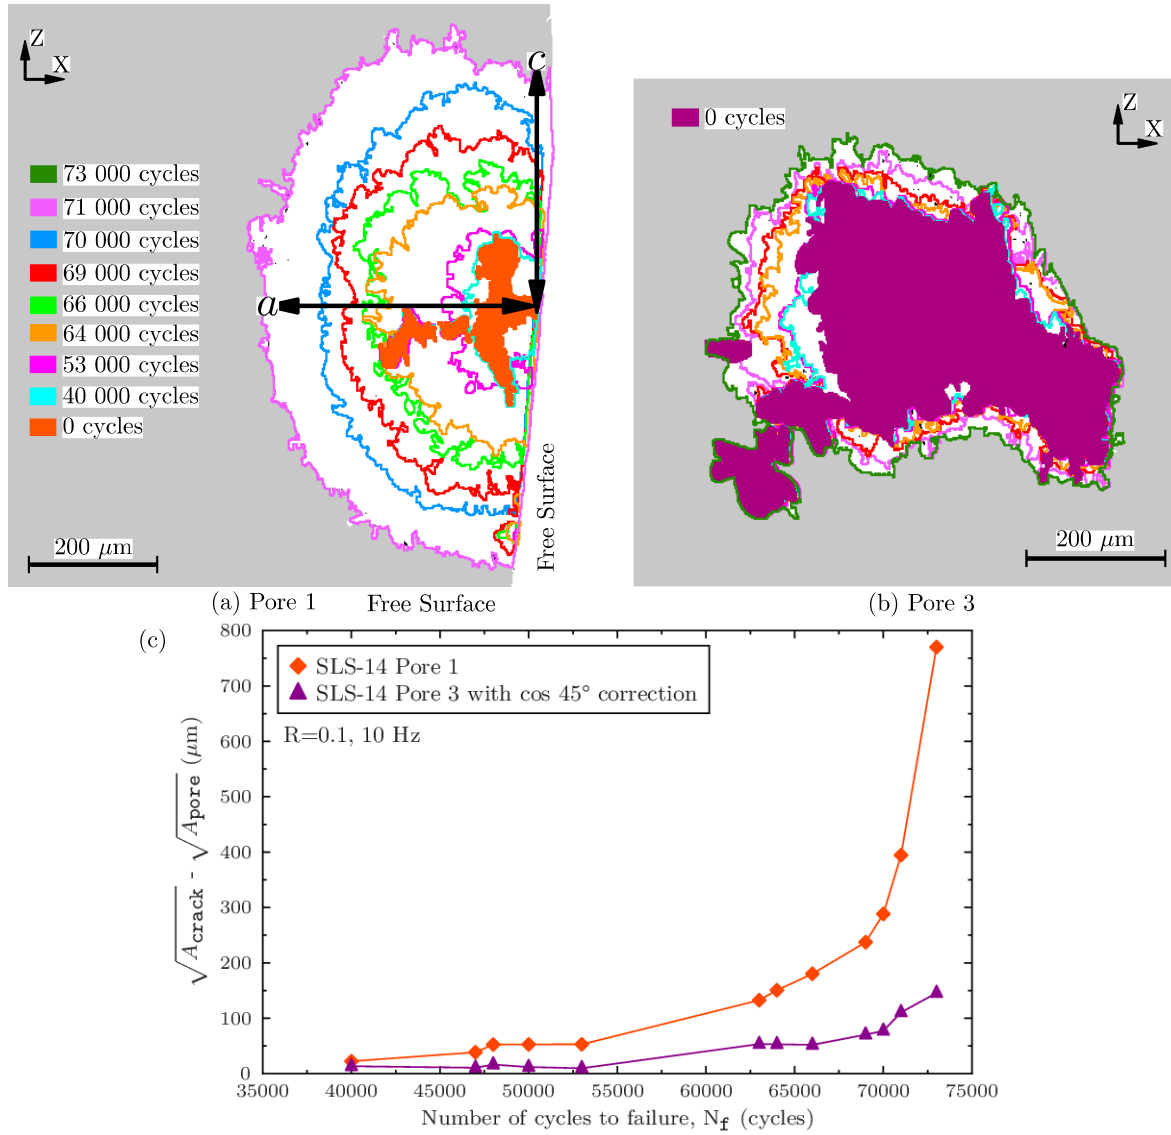
**Fig. 3.19:** SLS-14 specimen cycled at  $\sigma_{\text{max}} = 230 \text{ MPa}$ . (a) Y (loading direction) projection of the main growth stages for the crack nucleated at Pore 1 (some stages omitted for clarity). (b) Same as before but for the case of the internal pores. (c) Plot of the crack propagation ( $\sqrt{A_{\text{crack}}} - \sqrt{A_{\text{pore}}}$ ) against the number of cycles ( $N_f$ ) for these two pores.
